Open Sinus Lift Healing Comparison between a Non-Perforated Schneiderian Membrane and a Perforated Schneiderian Membrane Repaired with Amnion-Chorion Allograft Barrier: A Controlled, Split Mouth Case Report

Abstract

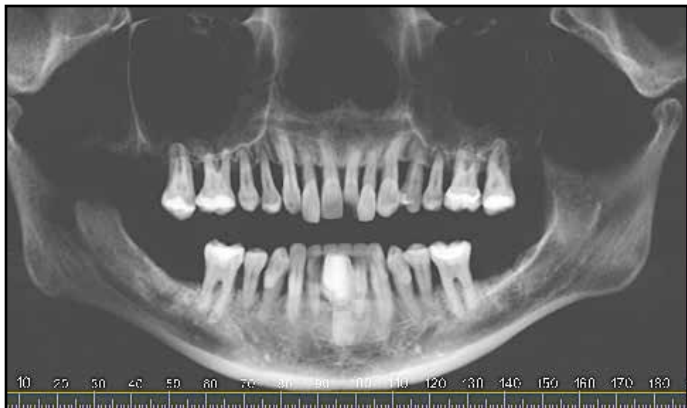
Figure 1: Presurgical CBCT scan of patient showing bilateral pneumatized maxillary sinuses and severe bone loss secondary to periodontal disease.

To accommodate the patient's desires for a dental implant supported fixed restoration of the maxilla, the patient's significant bone deficiencies had to be addressed. A cone beam computed tomography (CBCT) scan revealed that the patient not only had significantly pneumatized maxillary sinuses bilaterally (Figure 1), she also had minimal bone height and width in the anterior maxillary sextant (Figures 2, 3). Because of these findings, it was decided that bilateral maxillary open sinus lifts would be performed to gain as much bone height as possible in the posterior and mid maxilla. Once these bone augmentations healed, the patient would receive an additional CBCT scan and a guided dental implant surgery would be planned with at least 3-4 dental implants being placed into each augmented sinus.

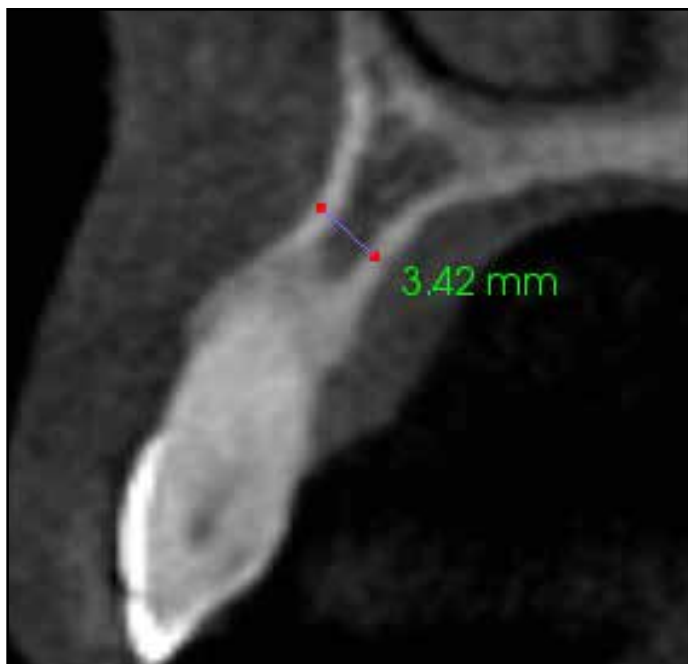
Figure 3: Presurgical CBCT scan (alternate view) showing minimal bone thickness in the maxillary anterior sextant.

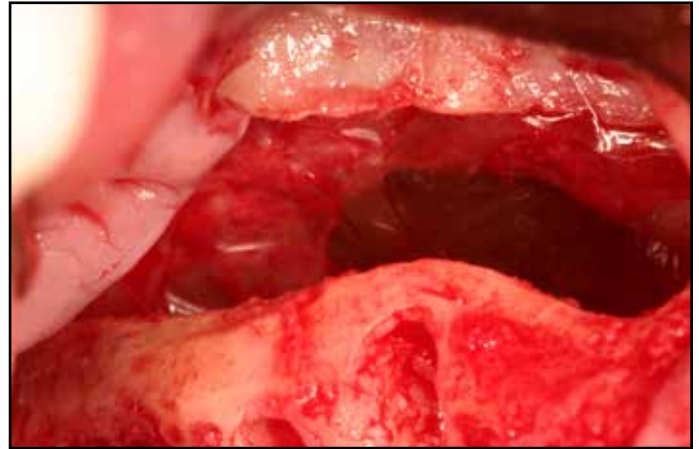
Figure 5: Amnion-Chorion barrier placed onto sinus membrane perforation. Note that no stabilizing sutures are required as the barrier self-adheres to the Schneiderian membrane.

membrane was elevated without complication, a large perforation occurred (Figure 4) during elevation of the right sinus membrane. To repair the sinus membrane perforation, a large piece of amnion-chorion barrier (BioXclude, Snoasis Medical, Denver, Colorado, USA) was placed directly onto the Schneiderian membrane (Figure 5). Care was taken to make sure that the amnion-chorion

barrier completely covered the sinus membrane perforation with extension of the barrier at least 3mm beyond the lateral borders of the defect. The amnion-chorion barrier was initially placed into the maxillary sinus dry (non-hydrated) which allowed for easy manipulation and movement of the barrier. Once placed into the desired position, the patient's own blood was utilized to hydrate

the amnion-chorion barrier. Upon hydration, the amnion-chorion barrier became very tacky and self-adhered to the Schneiderian membrane, thus eliminating any need for stabilizing sutures. Following repair of the perforated sinus membrane, a mixture of bone xenograft (Bio-Oss, Geistlich Pharma North America, Princeton, New Jersey,

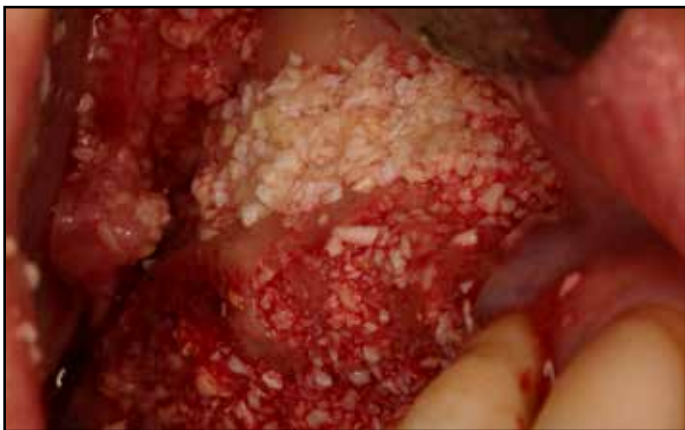
Figure 6: Placement of bone xenograft/allograft combination into the maxillary sinus and extraction sockets.

USA) and bone allograft (Maxxeus, Dallas, Texas, USA) was placed into the sinus cavity (Figure 6) and the lateral windows were covered (Figure 7) with amnion-chorion barriers (BioXclude, Snoasis Medical, Denver, Colorado, USA). The mucoperiosteal flaps were then reapproximated with 4-0 polytetrafluoroethylene sutures. Post-surgically,

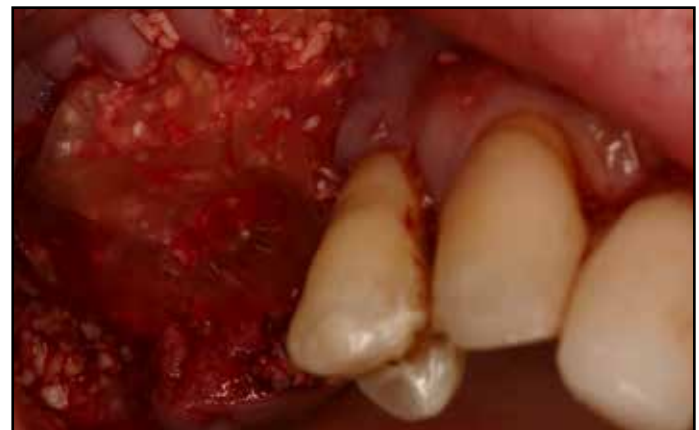
Figure 7: Amnion-Chorion barrier used to cover the lateral access window and grafted sockets.

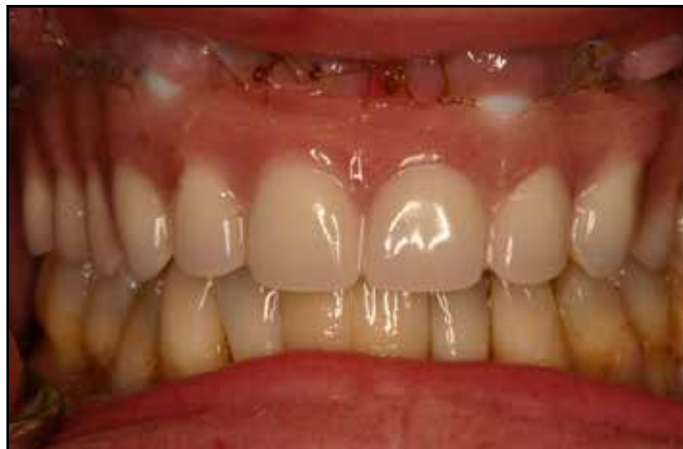
Figure 9: Immediately loaded maxillary transitional prosthesis.

cal procedure was carried out 150 days after the original surgical procedure. Following the administration of local anesthesia and intravenous conscious sedation, all remaining maxillary teeth were extracted and the surgical guide was affixed with three strategically placed pins. A total of 8 dental implants (NobelActive, Nobel Biocare, Yorba Linda, California, USA) were placed utilizing the surgical guide. Following removal of the guide, multi-unit healing abutments were placed on all implants with 15 Ncm of torque and white healing caps were screwed into the abutments (Figure 8). The patient was then released to the prosthodontist who adjusted and delivered an immediately loaded full-arch transitional prosthesis (Figure 9). The patient wore the transitional prosthesis for four months and then received a zirconia final restoration (Figures 10, 11).

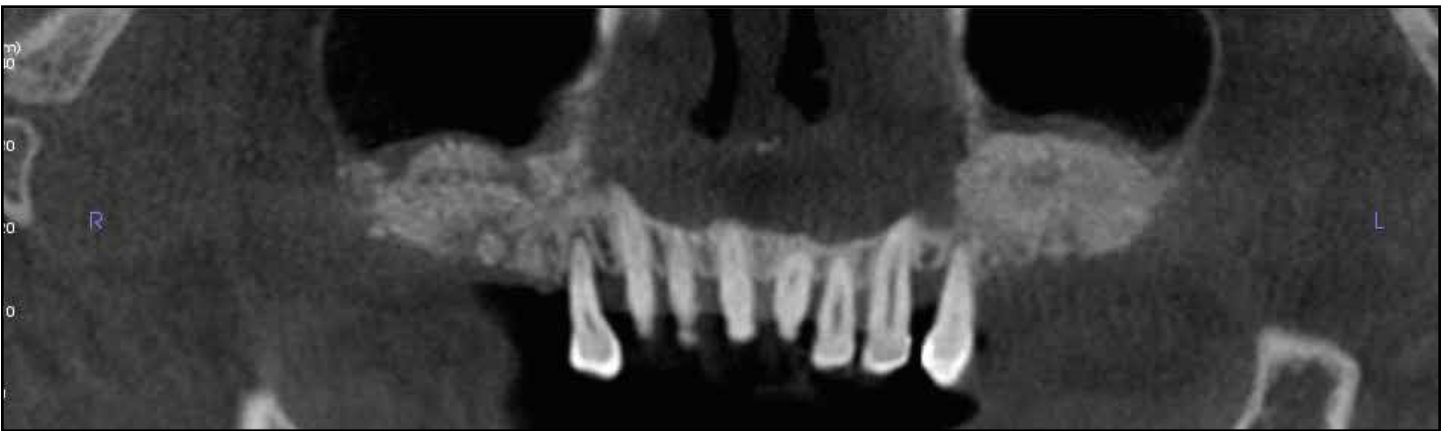
Figure 13: Postsurgical CBCT scan after maxillary sinus augmentations (coronal view).

days was compared to the pre-surgical CBCT scan for healing evaluation and comparison of the non-perforated augmented sinus versus the perforated repaired augmented sinus. In general, the non-perforated sinus showed a more dense bone fill compared to the repaired perforated side (Figures 12-15). When the area of the repaired sinus membrane perforation was examined in a transverse view via the CBCT scan, a well-defined radiolucent area was clearly visible (Figure 16). The non-perforated sinus had more bone fill vertically than the repaired perforated side (Figures 17-20). Although the repaired sinus did not achieve bone fill as robust or dense as the non-perforated side, adequate bone was still present for the placement of dental implants which were 11.5mm in length (Figure 21). All dental implants achieved at least 35 Ncm of torque at placement and allowed for immediate loading of a transitional prosthesis. The transitional prosthesis was placed in function for a total of four months without complication prior to the fabrication and delivery of a zirconia final restoration. After two years in function with the zirconia restoration, the patient has experienced no complications (Figures 22, 23). Comparisons of bone levels around the dental implants after two years in function revealed no difference in bone loss between the repaired perforated side versus the non-perforated side (Figure 24).

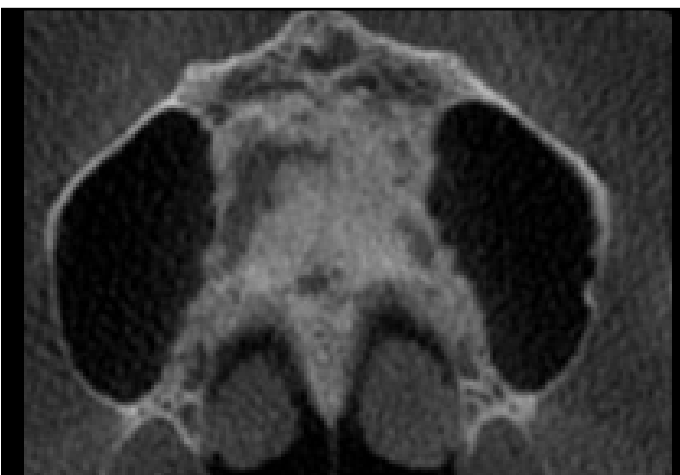
Figure 14: Presurgical CBCT scan prior to maxillary sinus augmentations (transverse view).

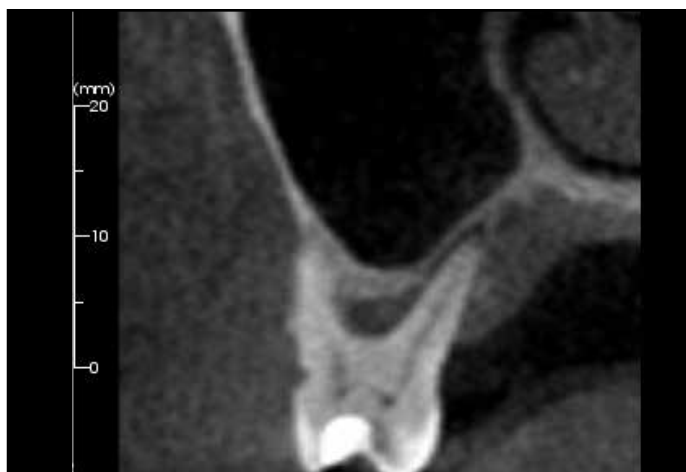
Figure 19: Presurgical CBCT scan of right maxillary sinus showing sinus pneumatization.

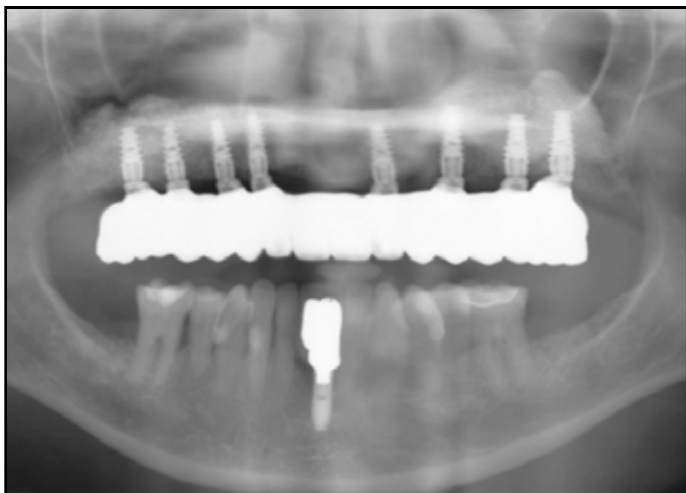
Figure 24: Radiograph of dental implants and final restoration after 2 years of function.
